# CHRIS CURLES and ASSOCIATES Inc. INSPECTION SERVICES

## Smith Framing Inspection Report.

**DATE:** September 30, 2008.  
**CLIENT:** Smith and Family.  
**SITE: ADDRESS:** 1111 Hickory Lane Lot 9-D.  
**CITY/STATE/ZIP:** Suwanee, GA 30024.  
**EMAIL:** xxxxxxx@hotmail.com.  
**PHONE:** (C) 404-xxx xxxx.

**BUILDING AGE:** New construction. Framing inspection only.  
**BUILDING TYPE:** Single family.

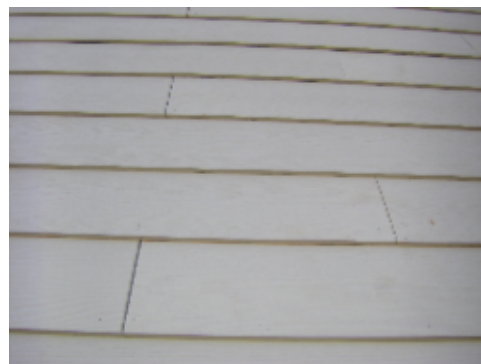
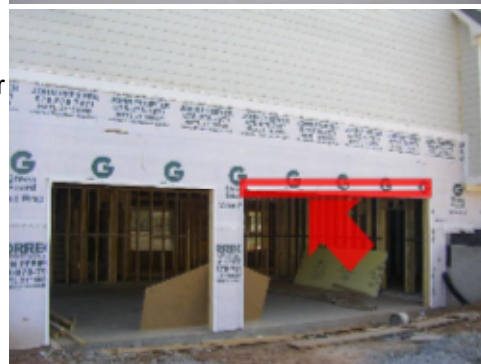
The brick has not been installed. Brick lintel will be installed over the window, doors and garage doors. The lintel over the two car door opening should be sized to support the load imposed above to help prevent deflection. It has been my experience that if the lintel is undersized or even sized to the minimum standards in the IRC, International residential Code, the lintel will deflect and cause separation between the bricks. I recommend you have the builder address this.

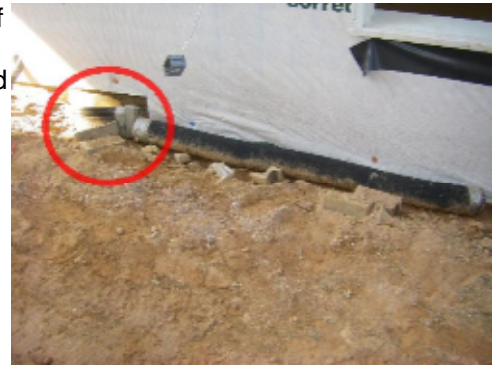
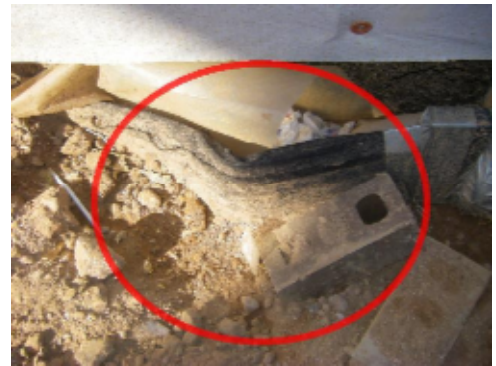
The footing drain along the right side of the home should be protected against damage. Currently, the drain is crimped and is above grade.

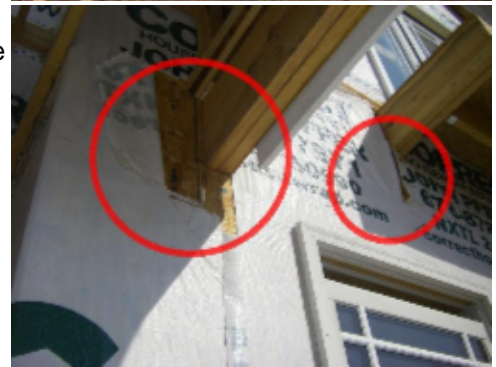
The vapor barrier, house wrap is damaged along the front and should be repaired.

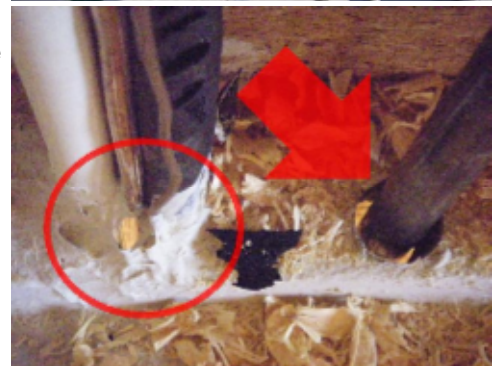
The firestopping should be improved around the A/C freon lines and gas line in the sole plate between the top floor and the attic as to the IRC. See photo.

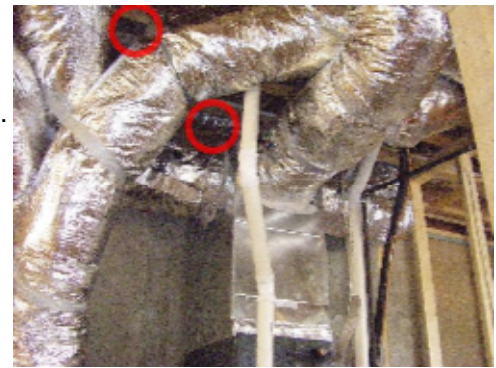
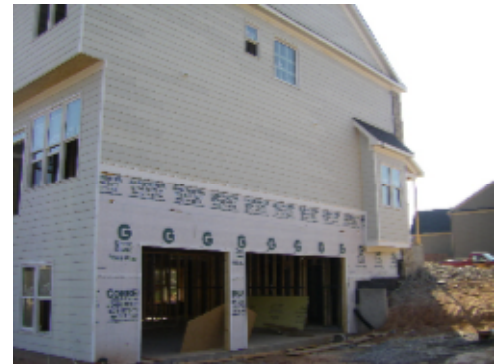
A passive Radon vent was requested by the purchaser to be installed in the basement utility room and extended to the attic. The vent could not be located.

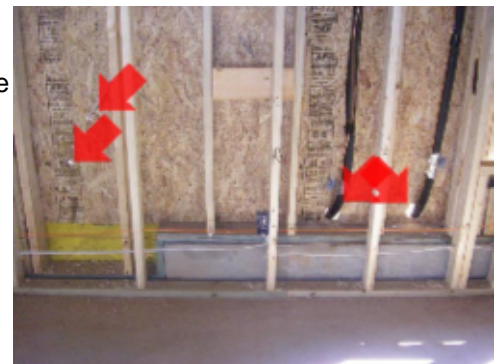
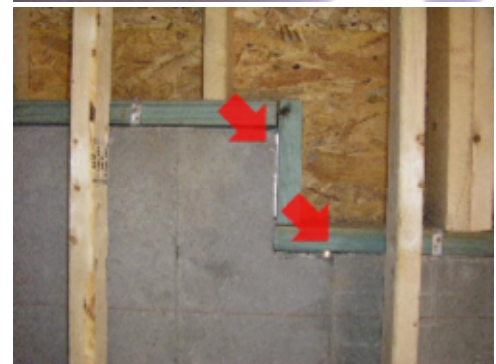
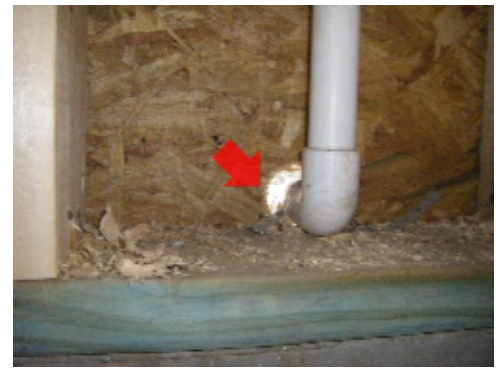
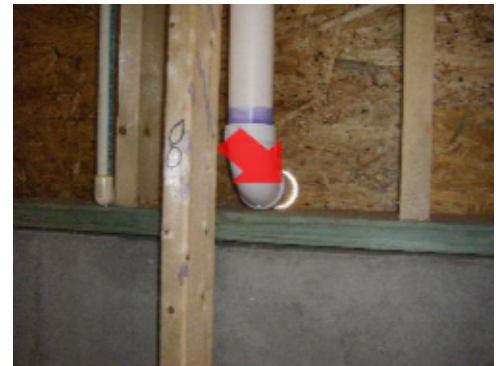
Openings in the wall sheathing will need to be filled to help prevent air intrusion. This will take place before the walls are insulated.

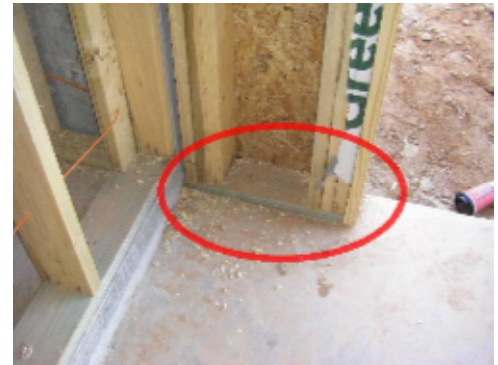
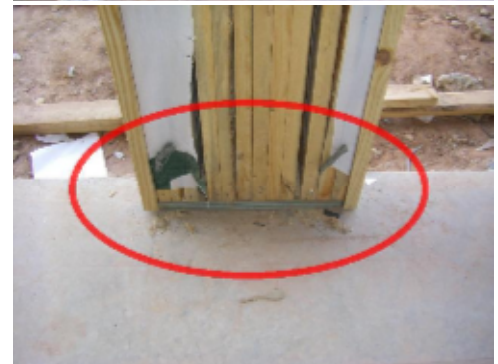
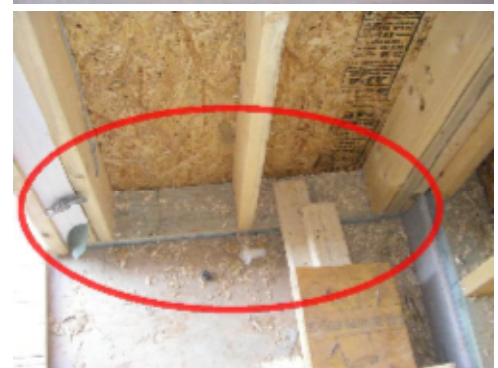
The framing for the garage door opening is not secured with a positive connection to the slab or foundation to prevent lateral displacement. See photos.

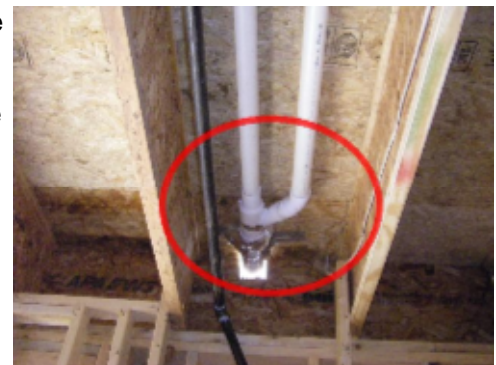
The combustion air intake vent and the combustable gas discharge vent are connected together in the basement ceiling near the exterior wall. Have the builder and the HVAC contractor address this condition to determine if the connection of the two vents was intentional.

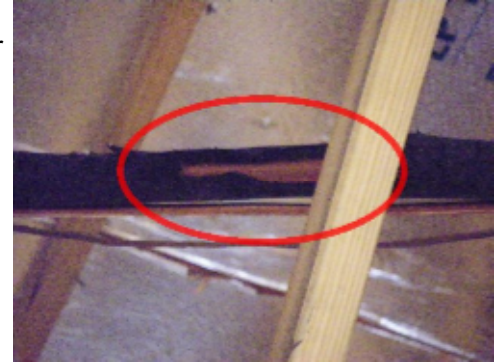
The insulation on the freon line is damaged in two places in the attic over the guest bedroom. Repair needed.
