# CHRIS CURLES and ASSOCIATES Inc. INSPECTION SERVICES

## Smith Framing Inspection Report.

**DATE:** September 30, 2008.  
**CLIENT:** Smith and Family.  
**SITE: ADDRESS:** 1111 Hickory Lane Lot 9-D.  
**CITY/STATE/ZIP:** Suwanee, GA 30024.  
**EMAIL:** xxxxxxx@hotmail.com.  
**PHONE:** (C) 404-xxx xxxx.

**BUILDING AGE:** New construction. Framing inspection only.  
**BUILDING TYPE:** Single family.

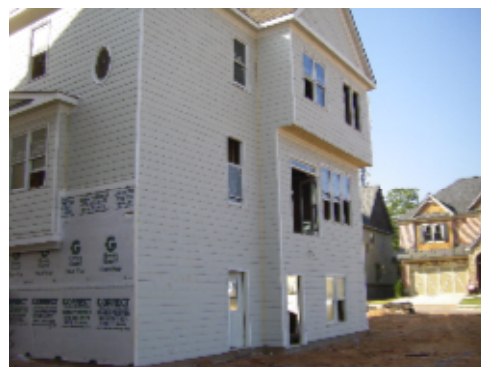
The siding along the sides and back appears to be cement fiber or masonry siding or Hardie Plank. See [www.jameshardie.com](http://www.jameshardie.com) or [www.jameshardie.com/homeowner/siding.shtml](http://www.jameshardie.com/homeowner/siding.shtml) for manufacturer's specifications regarding warranties, installations and maintenance. Click on, Siding Products then click on, Installation. You can copy and down load information from this site. Final inspection of this product will be before closing.

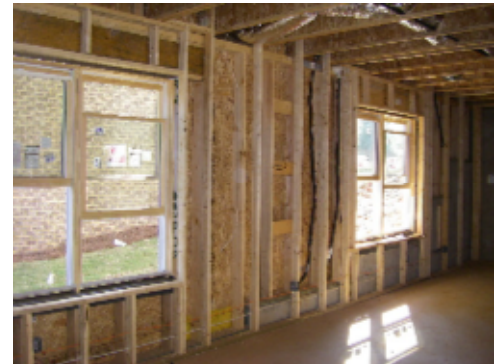
Appears serviceable where visible.  
Appear serviceable where visible.  
Not installed at the time of the framing inspection.

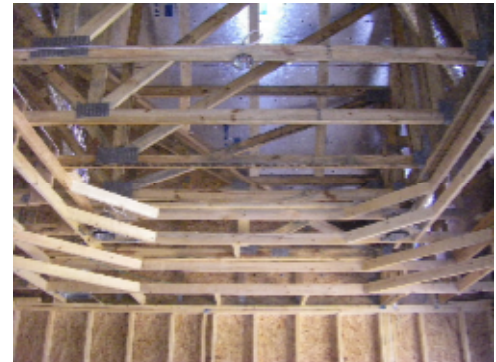
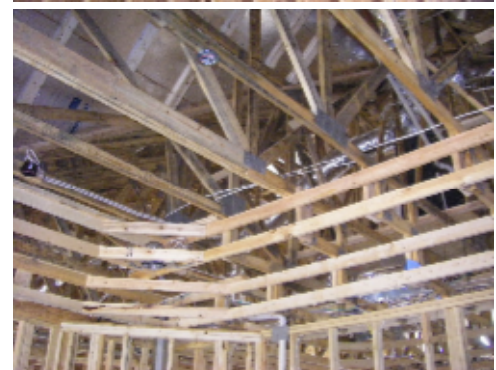
TeckShield decking has been installed throughout the attic. I have attached a web site that will address this products and the benefits. <http://www.lpcorp.com/radiantbarrier/radiantbarrier.aspx>

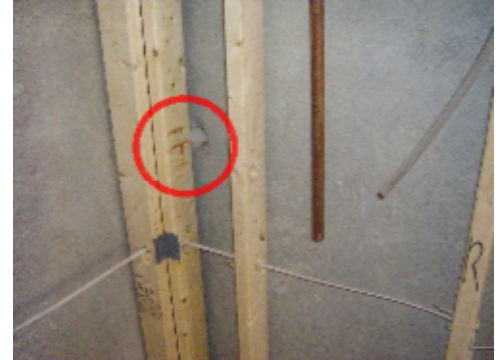
Water service was not installed at the time of the inspection.

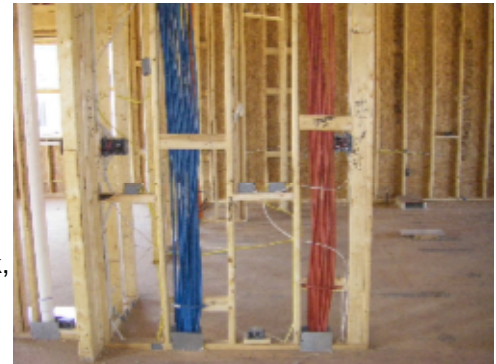
PEX water pipes noted. What is PEX?

PEX is cross-linked polyethylene. Through one of several processes, links between polyethylene molecules are formed to create bridges (thus the term "cross-linked"). This resulting material is more durable under temperature extremes, chemical attack, and better resists creep deformation, making PEX an excellent material for hot water and other applications.
